Pipetman[®] Care and Maintenance

Complete Guide to Troubleshooting and Repairing Pipetman
Pipette Models P-2 through P-10ML and P-200-M8

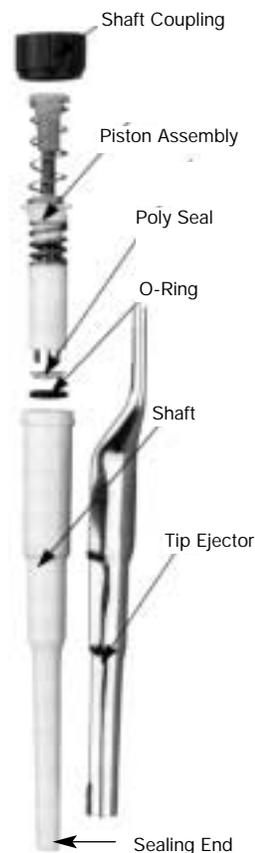
O-Ring: Extremely durable and not subject to wear. Does not usually require replacement.

The original P-10ML seal (pre s/n N05803D) is formed by an O-ring with fluorinated grease. Remove the old O-ring and clean all traces of grease from piston. Smear a light coat of fresh grease on the new O-ring and piston. Reassemble.

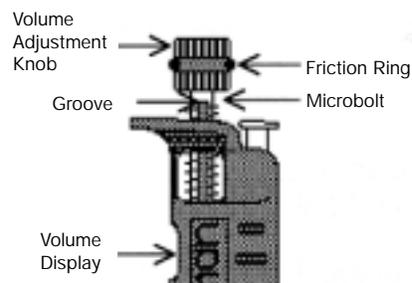
1. Rotate the volume adjustment knob counter-clockwise until the microbolt assembly can be removed. Once removed, view the white tab (key) inside the Pipetman body. This tab allows manual manipulation of the digital display.
2. Mount the new friction ring (P/N 400114). The ring may need to be adjusted to assure proper seating.
3. If necessary, reset the digital display as indicated in **V1** by using extended forceps to manipulate the white tab.
4. Reinsert the microbolt assembly into the Pipetman body without rotation of the volume display. Note: The tab inside the body must align with the groove on the microbolt. Then screw the volume adjustment knob past zero until it will rotate no further. The volumeter display should correspond with **V2** below.

<u>Model</u>	<u>V1</u>	<u>V2</u>
P-10, P-100, P-1000, P-10ML	130-133	996 ±3
P-2, P20, P-200	310-315	980 ±5
P5000	630-675	970 ±5

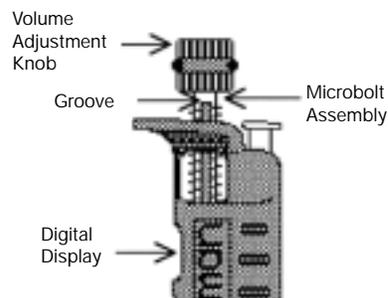
1. Rotate the volume adjustment knob counter-clockwise until the microbolt assembly can be removed. Once removed, view the white tab (key) inside the Pipetman body. This tab allows manual manipulation of the digital display.
2. By using extended forceps, reset the digital display as indicated in **V2** by manipulating the white tab.
3. Reinsert the microbolt assembly into the Pipetman body without moving the digital display. Align the groove in the microbolt with the white tab. While applying downward pressure, wind the volume adjustment knob clockwise until no further travel of the microbolt assembly is allowed.
4. View the digital display and compare to **V1**. If the display value exceeds the range, the micrometer is still not properly zero-set. Try again.

<u>Model</u>	<u>V1</u>	<u>V2</u>
P-10, P-100, P-1000, P-10ML	996 ±3	130-133
P-2, P-20, P-200	980 ±5	310-315
P-5000	970 ±5	630-675
Plunger-Adjustable Pipetman:		
P-10, P-100, P-1000	995 ±1	135 ±3
P-2, P-20, P-200	980 ±5	325 ±5
P-5000	970 ±10	670 ±10

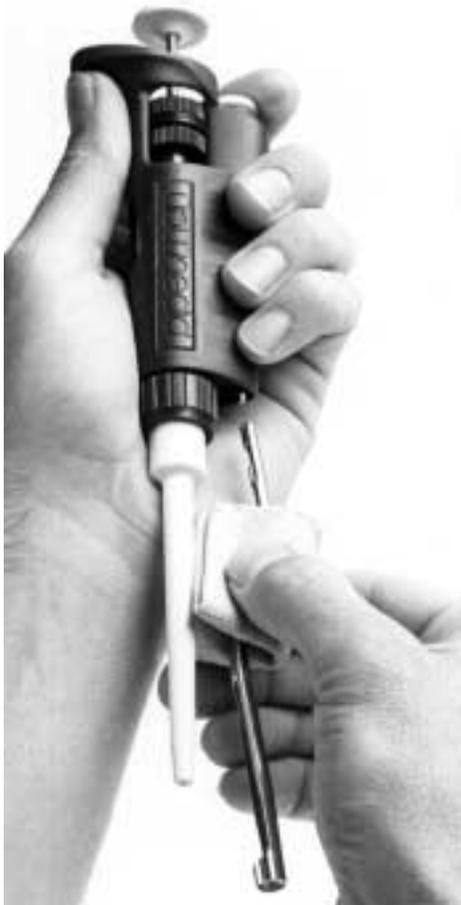
REMOVING THE TIP EJECTOR ARM

Press the tip ejector button and pull the tip ejector arm out from the instrument handle.

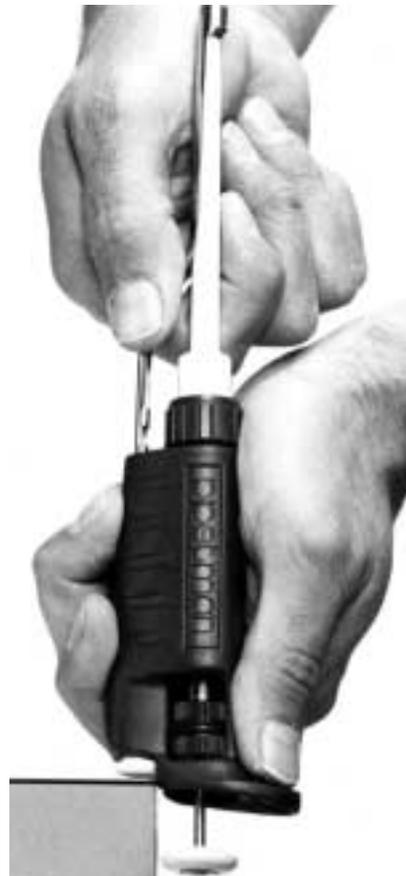
REPLACING THE TIP EJECTOR ARM

Hold the instrument upside down with the tip ejector button pressed against a table edge and the plunger hanging over the edge. Place the upper end of the ejector arm onto the post inside the instrument handle and press. Make sure the ejector arm is pushed into the handle so the tips will fit properly on the shaft.

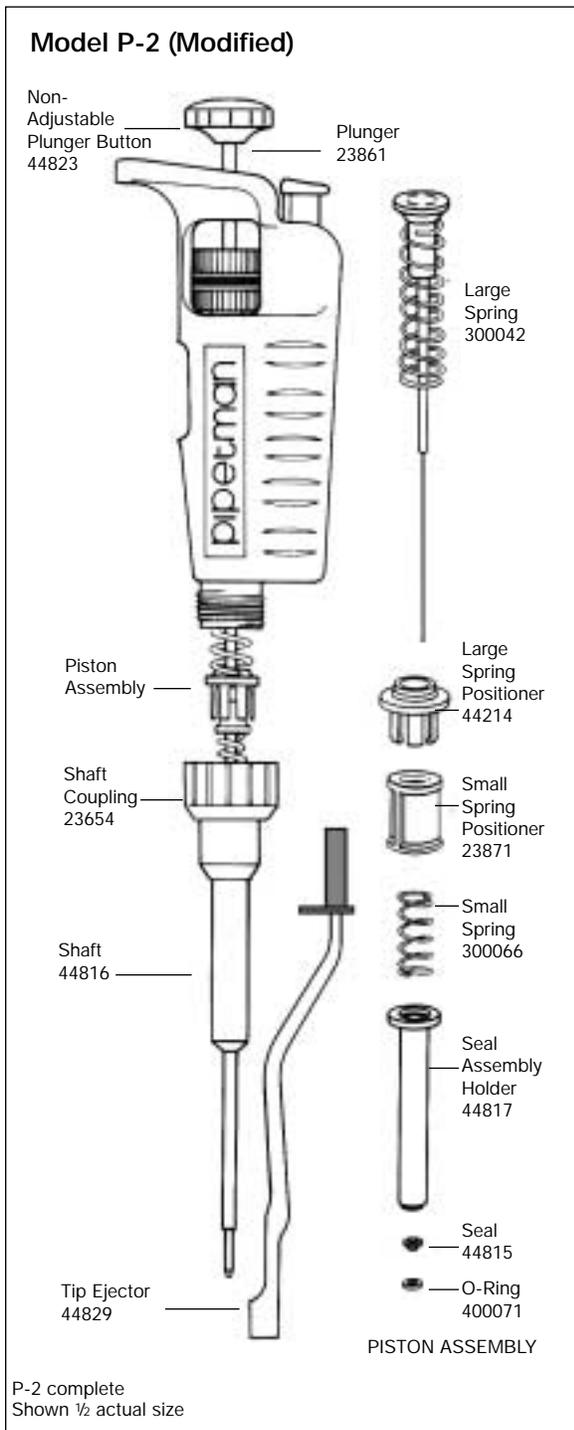
Adjustable Plunger
Button: 844781
Plunger: 44761

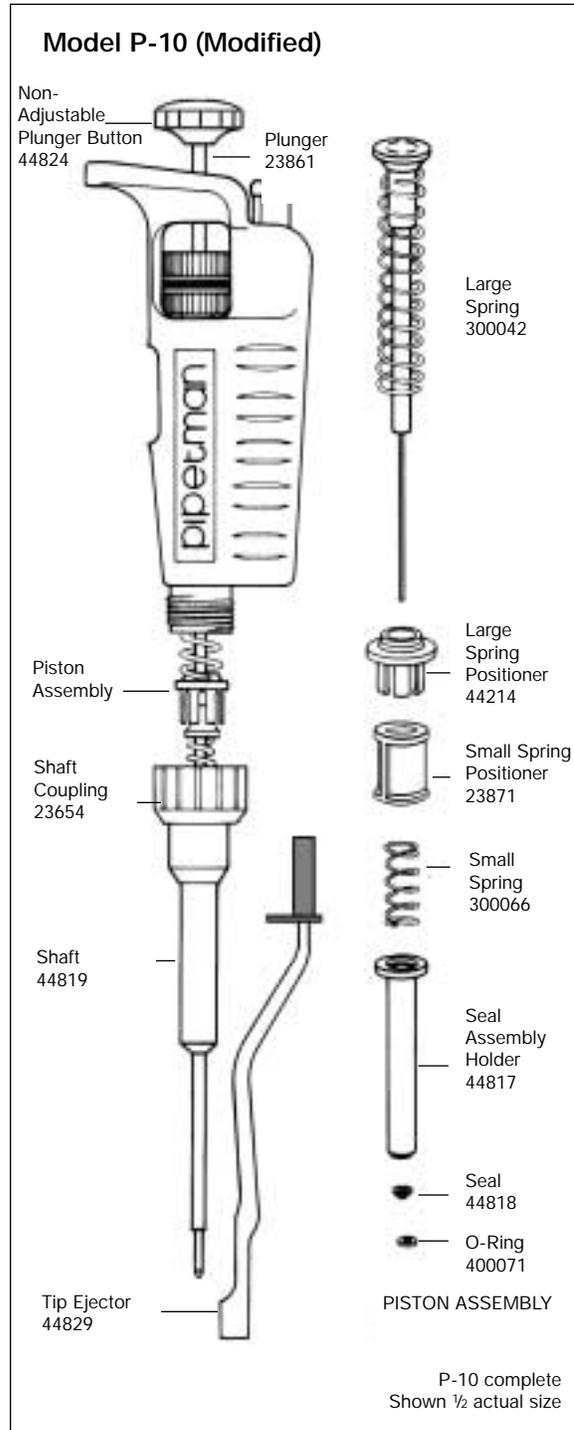
Adjustable Plunger
Button: 844782
Plunger: 44761

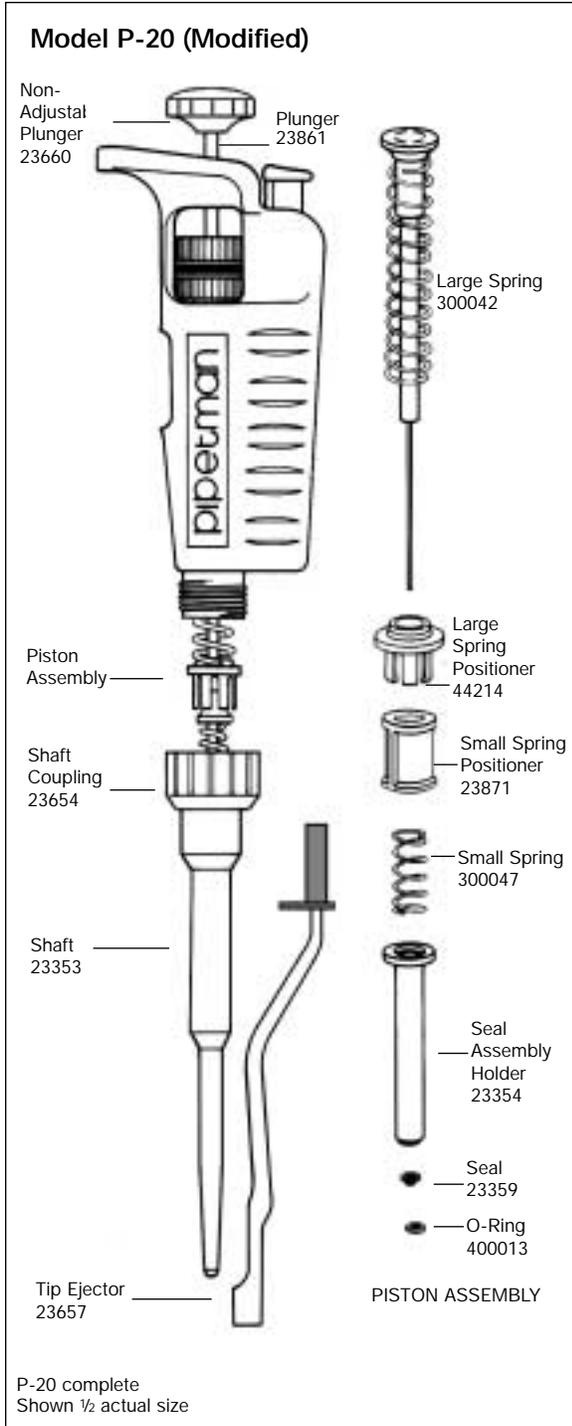
Adjustable Plunger
Button: 844783
Plunger: 44761

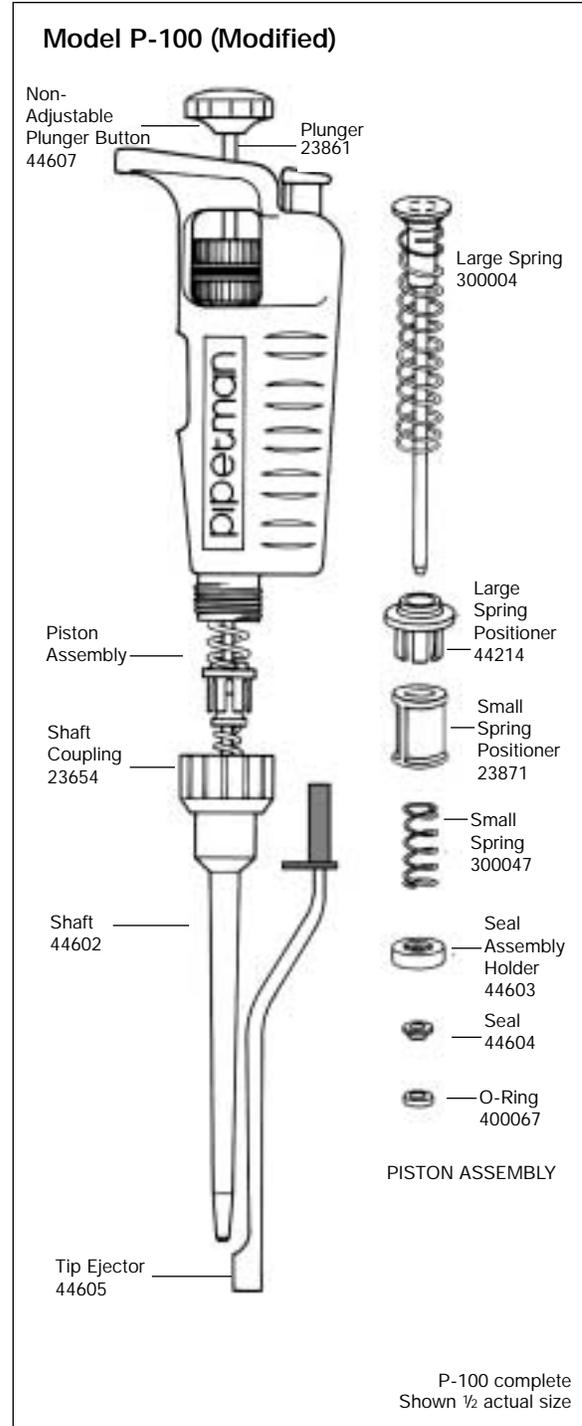
Adjustable
Plunger Button:
844784
Plunger: 44761

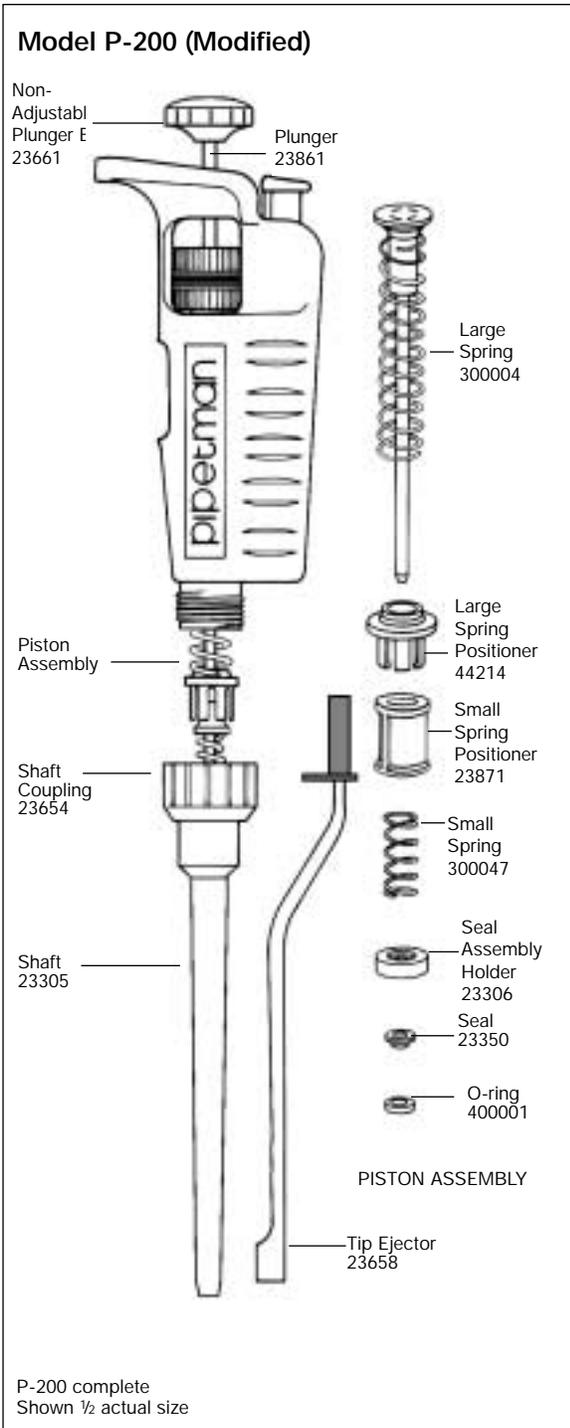
Adjustable Plunger
Button: 844786
Plunger: 44761

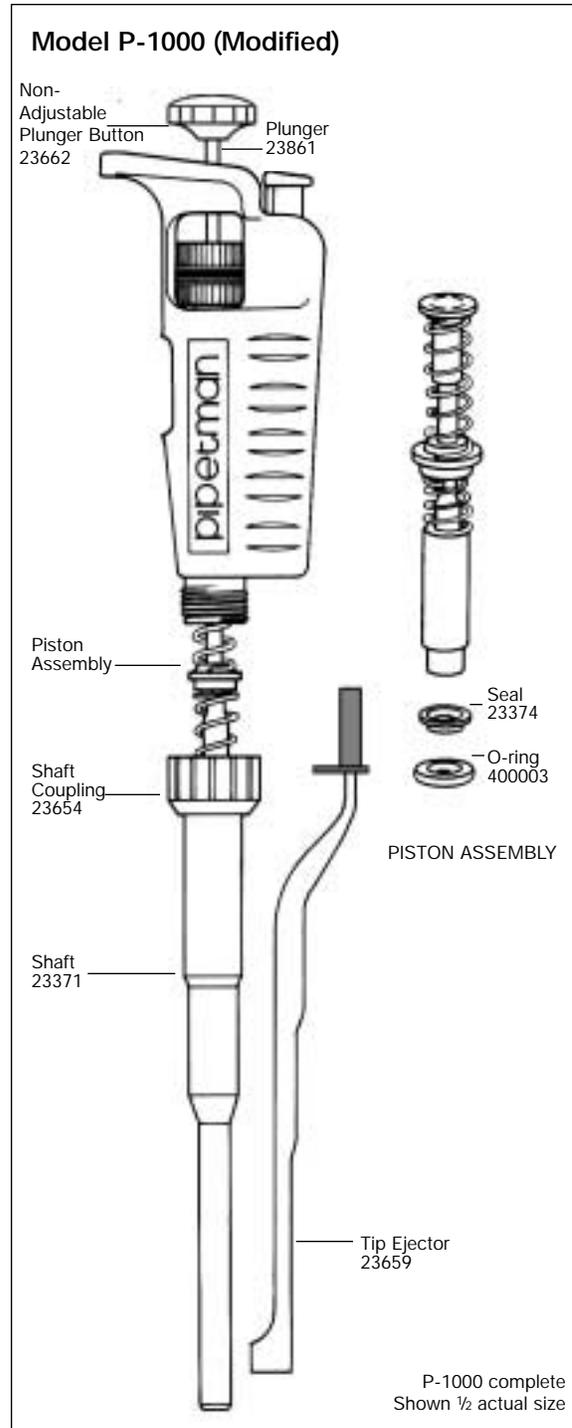
Adjustable
Plunger Button:
844786
Plunger: 44761

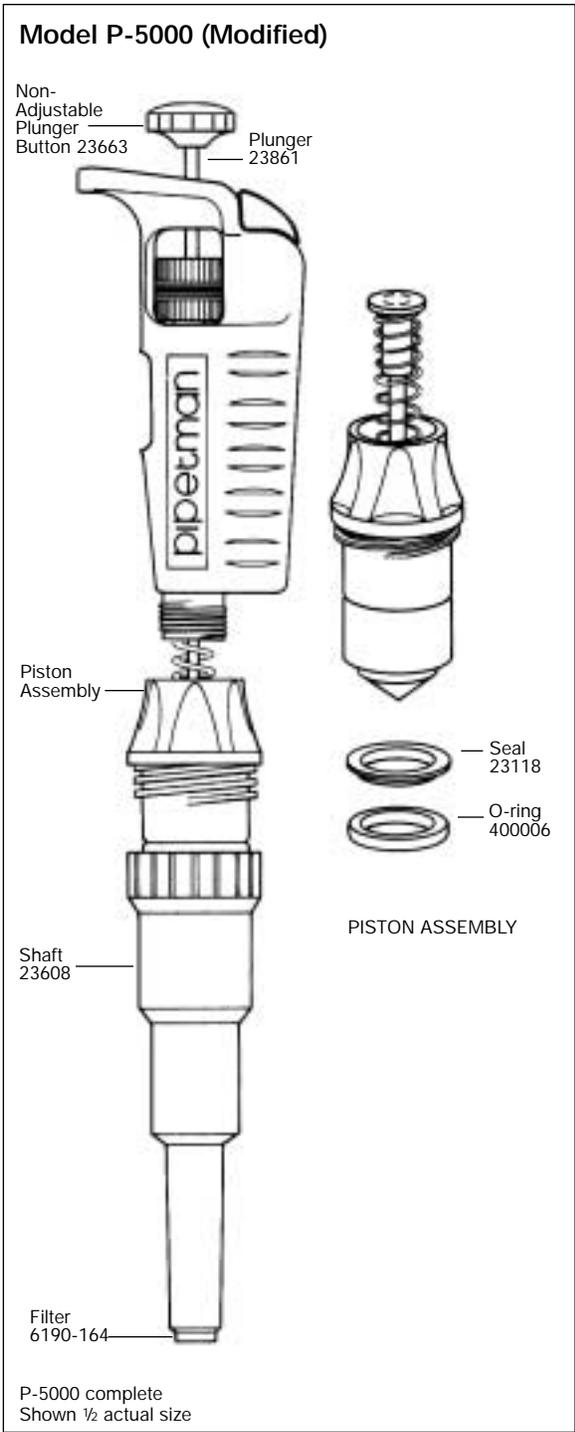
Adjustable Plunger
Button: 844787
Plunger: 44761

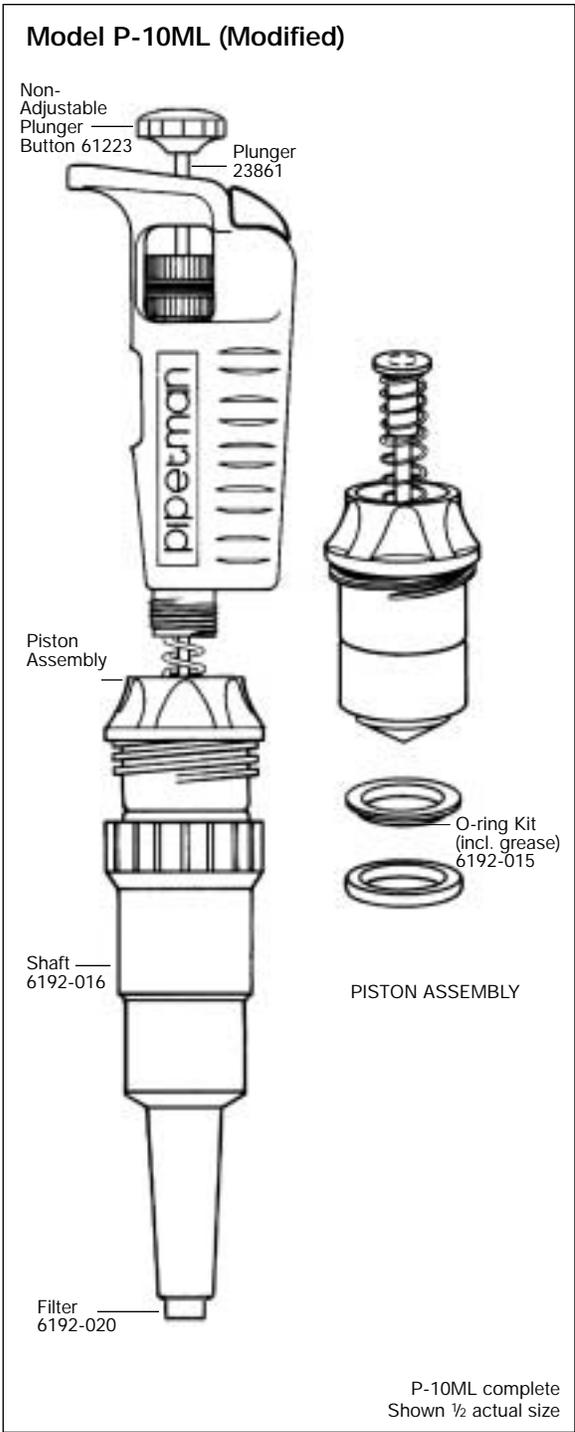
Adjustable Plunger
Button: 861281
Plunger: 44761

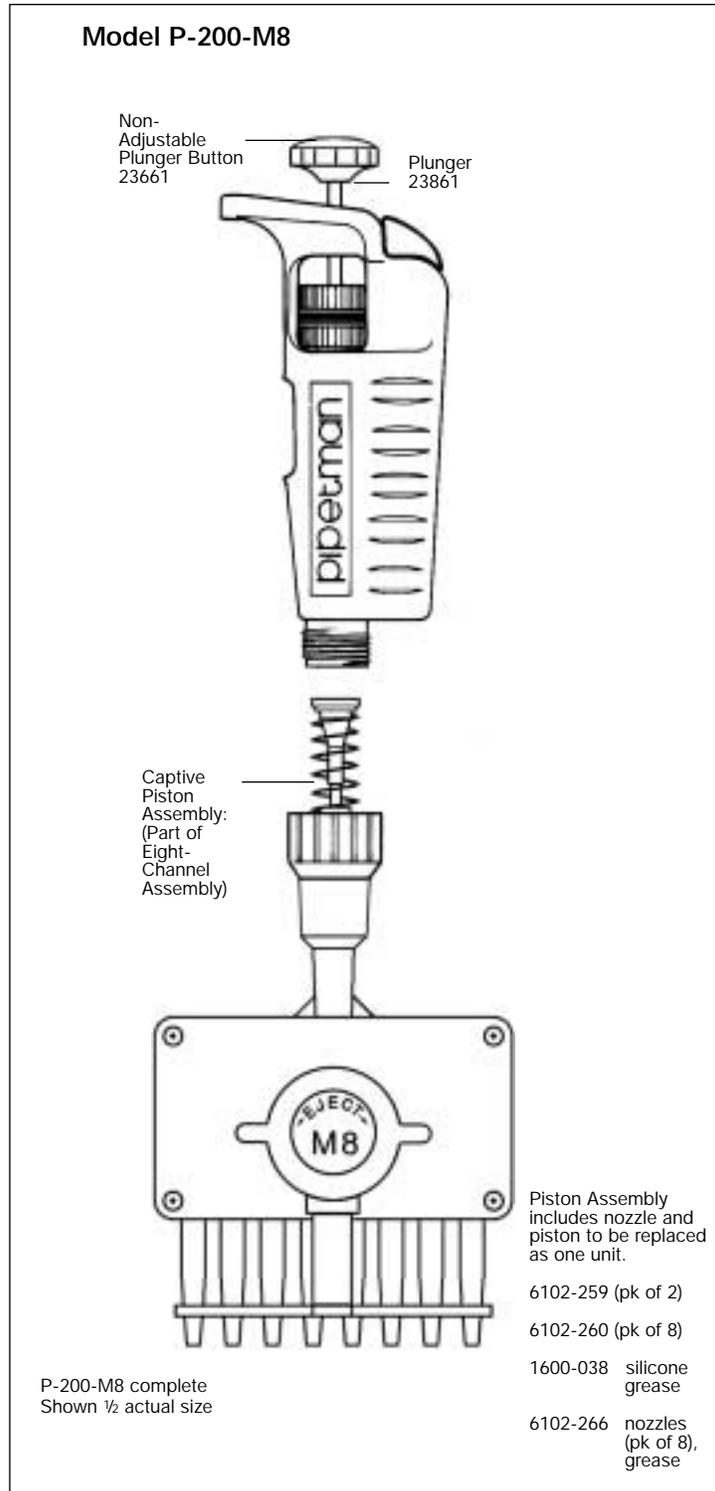
PIPETMAN® P-200-M8 MULTICHANNEL PIPETTE

Adjustable Plunger
Button: 861081
Plunger: 44761
